Conservation and observations regarding wall paintings in TPC Area Space 562

Ian Channell and Olja Mladjenović

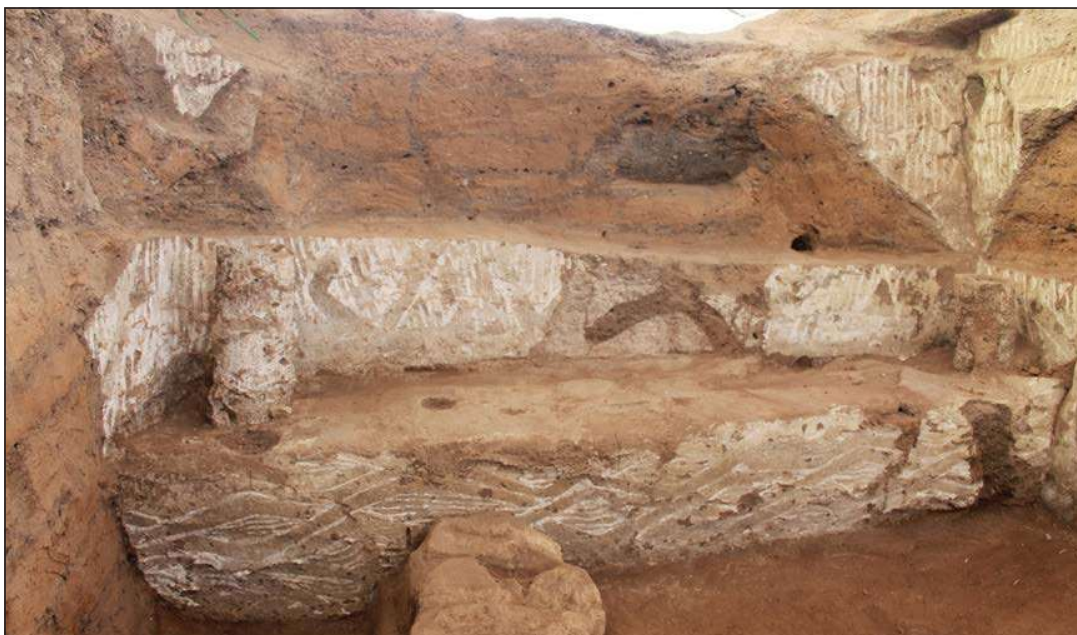
Figure 15.6. North wall and bench structure of Sp.562.

Wall paintings are located in Sp.562 in the TPC Area trenches. The geometric motifs are comparable to those previously revealed in B.121 in the 2013 season (see 2013 Archive Report). The geometric motifs are prominently featured on the north and east walls of the space, an area that is cited as the most frequent location for wall paintings in buildings at the site (Çamurcuoğlu 2013). In the north wall, the painting envelops a large bench or ‘alter’ structure, which has two cylindrical white plaster constructions emerging from its eastern and western terminations. These structures appear to be internally hollow and were covered in white, powdery plaster with infrequent reddish, pink detail. It was difficult to discern the entirety of the design, but vertical lines and a diamond pattern could be surmised. On upper areas of the north wall, the painting is composed of vertical lines on the western and eastern corners. The distinctive shape of these features is due to a previous bell-shaped cut into the building. On the back of the upper section of the platform are large angular rhomboidal designs with an extensive border free of detail. Surrounding the rhomboidal designs are a continuation of the vertical lines. On the western section of the wall painting, it was detected that the vertical lines appeared to continue directly on top of the bench surface. After investigations, only intermittent detail was detectable and a slight single borderline was apparent between the bench surface and wall interfaces. A large section midway behind the bench appears to have extensive burrowing damage that has left the artwork in the vicinity in poor condition.

Below the bench are beautiful horizontally elongated lozenges with internal wave-like detail; a thick border that crosses over between every rhomboid shape binds each lozenge. On the eastern wall, vertical lines were found in its northern section, with lines decreasing in size along the length of the wall. It is unknown whether this design was intentional or whether it reflected further burrowing damage.

The paintings were revealed by mechanically removing layers of plaster from the painting surface. Mechanical removal allowed for detailed and controlled removal of the overlying plaster layers. Due to the three-dimensional and protruding aspect of the plaster/binder designs, most overlying plaster fractured easily from the artwork surface. Vertical lines were easier to uncover as the scalpel could be grazed over the design and the overlying plaster could be readily sheared off. Horizontal detail, such as those located below the bench, were more difficult to remove as the directionality of application of the scalpel made it difficult to remove the overlying plaster without damaging and shearing off the design with the covering plaster layers.

Following mechanical removal, the paintings were consolidated with a spray of 2.5% Paraloid B48N w/v in acetone. Paraloid B48N is an acrylic resin first developed by the Rohm and Haas Company as an alternative to commonly used Paraloid B72 (Horie 2010). Paraloid B48N is composed of a 75: 25 ratio of methyl methacrylate to butyl methacrylate with a high glass transition temperature (T_g) of 50°C which is suitable to the site's hotter summer environment (*ibid*). Paraloid B72 adhesive is frequently utilized within Çatalhöyük's conservation laboratory, but due to its T_g of 40°C, it is most frequently used on important small finds being stored in controlled conditions. Paraloid B48N is regularly utilized as metal coating (Freyer et al 2011) and as an adhesive for ceramics (Paterakis 1997) and stone objects (Jorjani *et al.* 2002; Riccardelli *et al.* 2010). The Paraloid B48N pellets are mixed in acetone in the conservation laboratory and applied to the surface with a spray bottle. It was determined that applying the consolidant spray in the lower portion of the wall increased structural support for the upper sections.

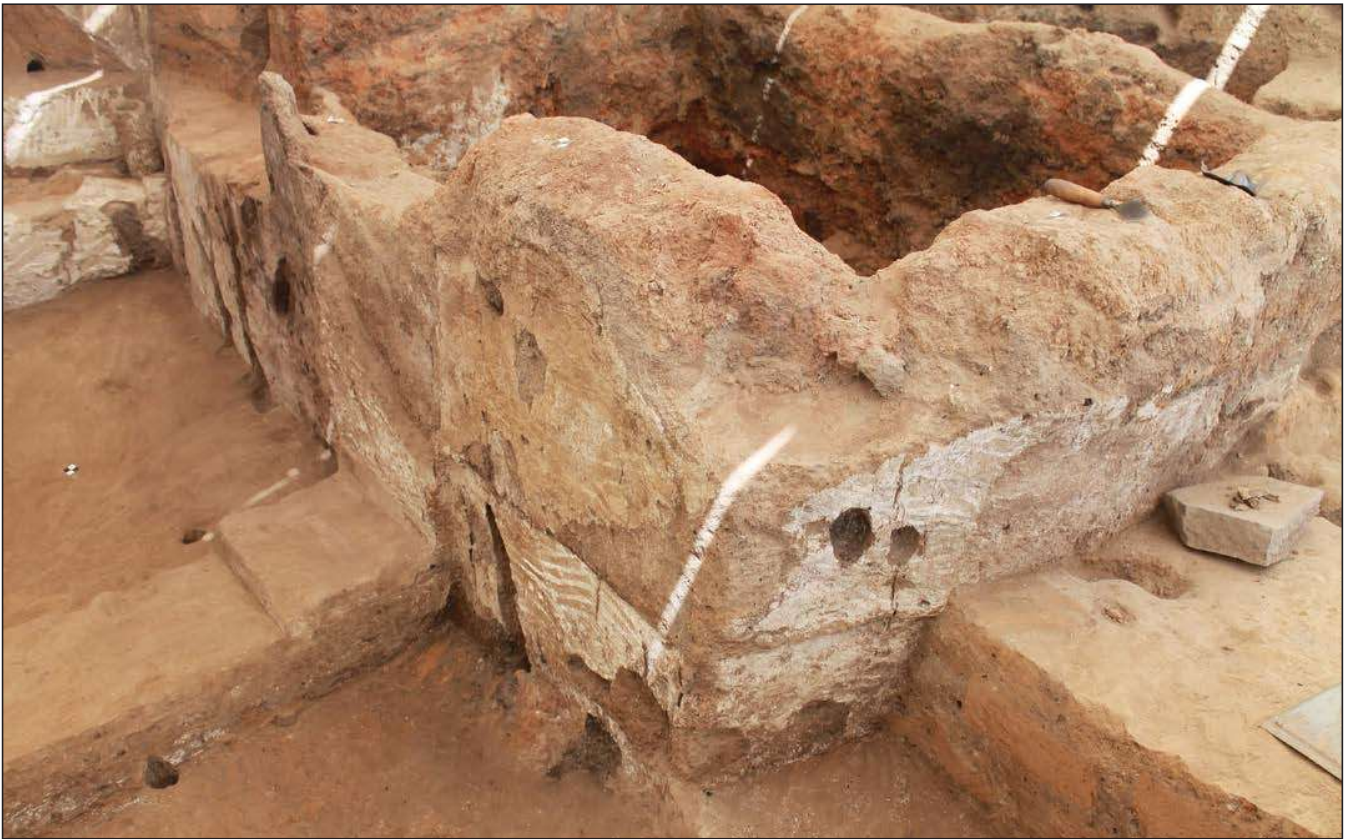
Figure 15.7. Eastern and south facing walls of Sp.562.

The building is divided by a platform that extends across the width of the room. On the eastern wall in this demarcated area, is a continuation of the painting uncovered by the conservation team early in the season. Both the above and below paintings reflect a circular pattern surrounding a central ovoid shape. These patterns extend around the corner to the south-facing wall. The upward portion of the painting is located on a protruding layer with the inferior portion on a depressed layer. It is postulated that this painting continues along the length of the south facing wall, however, further conservation and archaeological work will be needed to determine the extent of this feature.

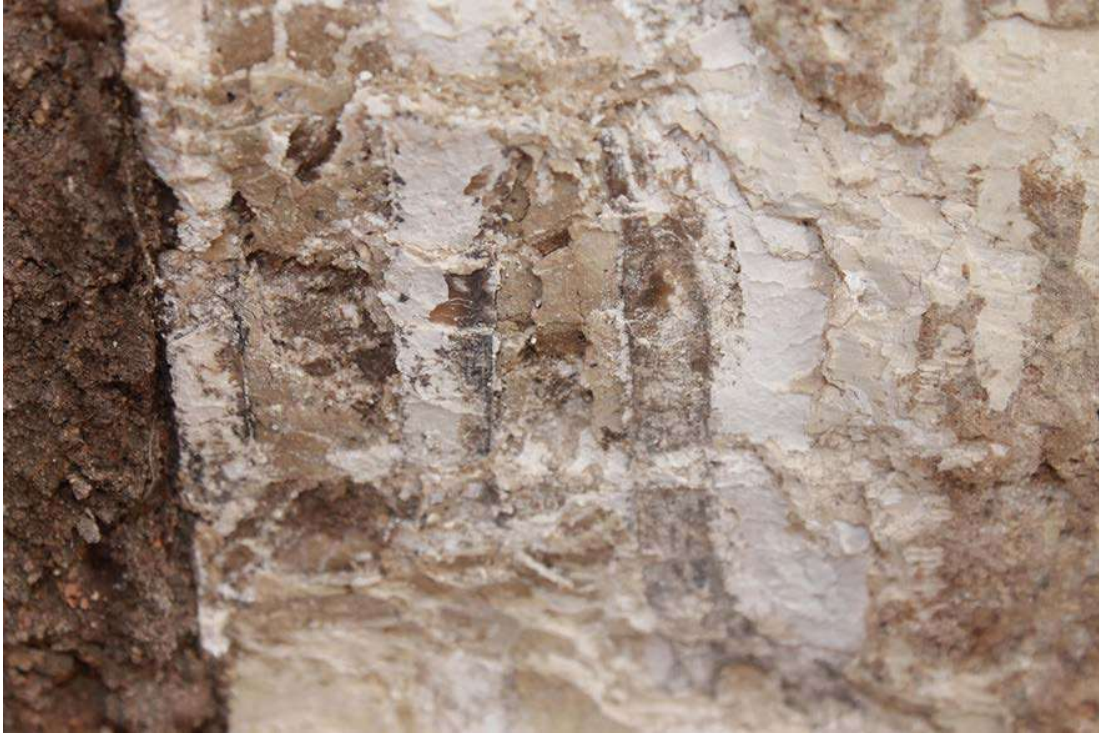
Figure 15.8. Brown colored binder underlying plaster detail.

Close examination of the painting during conservation treatments allowed for thorough observations of the painting construction. It became apparent that the design was not constructed through pigmented media, but was created entirely through plaster designs. Removal of the overlying plaster occasionally removed plaster from the design, revealing a yellowish brown and peach shade underneath (Figs. 15.8 and 15.9). It is suggested that this material is a binder or film-forming layer. A binder, possibly egg/yolk, linseed/olive oil, milk, rabbit skin glue (see Çamurcuoğlu 2013), holds and solidifies the material. It is postulated that the

plaster was mixed with the binder media, allowing for drying and setting on the wall surface. Fourier transform infrared (FTIR) analysis (Perkin Elmer Spectrum One) of the material at Cardiff University failed to discern the composition of the binder, most likely do to mixing with plaster or long-term degradation of the binder component. FTIR analysis did confirm the white material as calcium sulphate (gypsum).

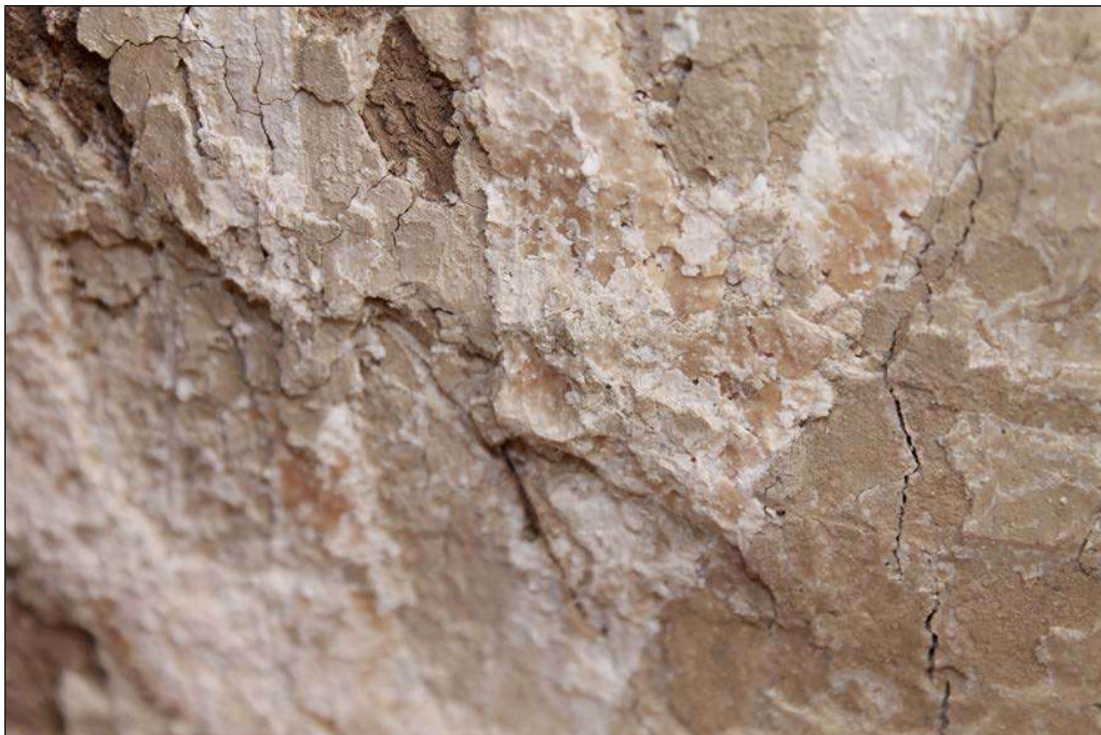
Figure 15.9. Yellow colored binder underlying plaster detail.

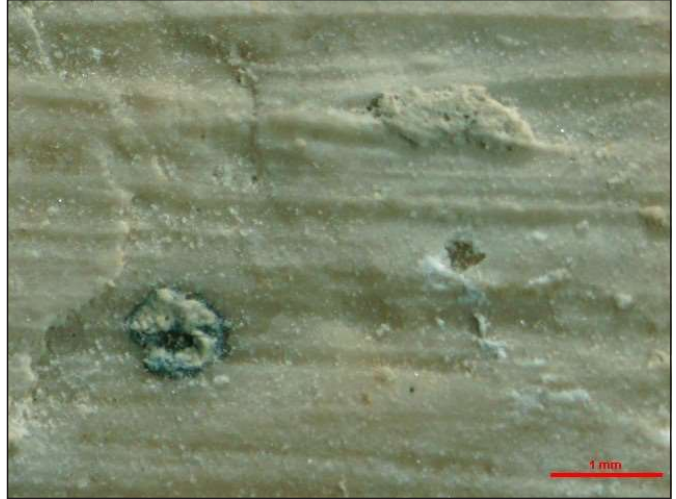
Microscopic evaluation with raking light of the binder reverse located numerous ridges, suggesting the plaster and binder material was applied via a brush, tool or cloth to the wall surface (see Çamurcuoğlu 2013 for discussion of application methods). Mirrored marks were also apparent on the wall when the binder was removed. Microscopy was preformed using Nikon SMZ1000 Stereomicroscope, Intralux 500 fibre optic illuminator, and NIS Elements D 3.0 Microscopic Imaging Software (Figs. 15.10 and 15.11).

Figure 15.11. Optical microscopy evaluation of binder reverse, x15 magnification.
